FINAL REPORT
JULY 1993

REPORT NO. 93-08

TRANSPORTABILITY TEST OF
EXTRUDED ALUMINUM
CONTAINERS SECURED WITH
U.S. AIR FORCE (USAF) CHAINS IN
A SIDE-OPENING CONTAINER

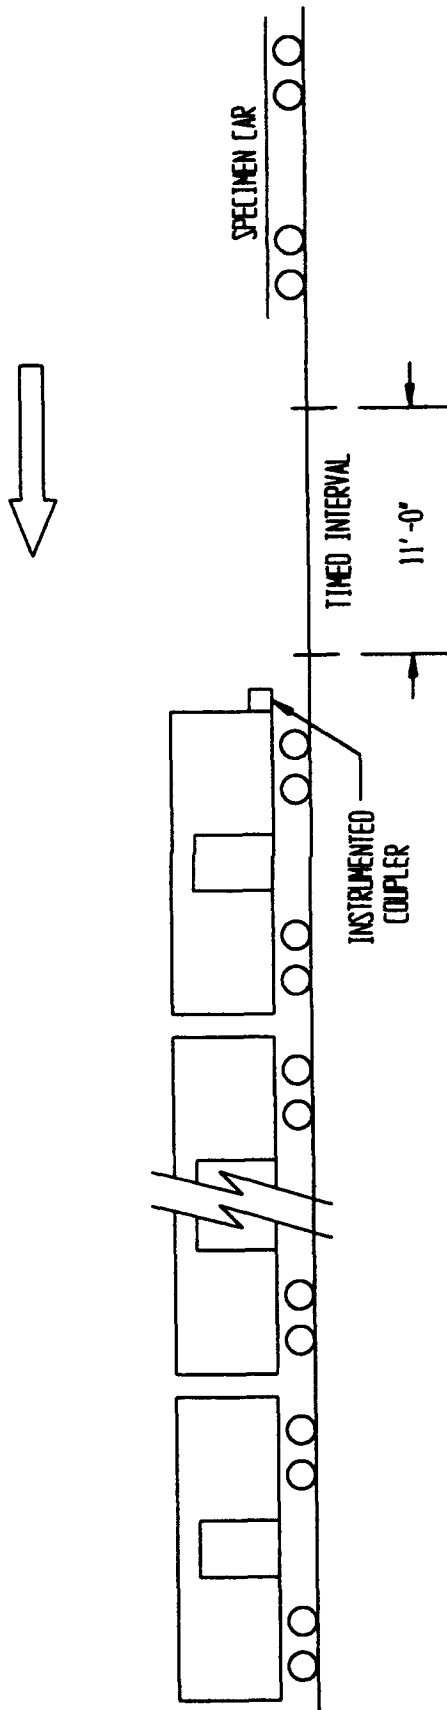
FIGURE 1

5 BUFFER CARS (ANVIL) WITH DRAFT GEAR
COMPRESSED AND AIR BRAKES IN A SET
POSITION
ANVIL CARS TOTAL WT 250,000 LBS (APPROX)

SPECIMEN CAR
IS RELEASED BY
SWITCH ENGINE TO
ATTAIN: IMPACT NO. 1 @ 4 MPH
IMPACT NO. 2 @ 6 MPH
IMPACT NO. 3 @ 8.1 MPH

THEN THE CAR IS REVERSED AND
RELEASED BY SWITCH ENGINE TO
ATTAIN: IMPACT NO 4. @ 8.1 MPH

compressed. The locomotive unit pulled the specimen car several hundred yards away from the anvil cars, then pushed the specimen car toward the anvil at a predetermined speed, and then disconnected from the specimen car approximately 50 yards away from the anvil cars, which allowed the specimen car to roll freely along the track until it struck the anvil. This constituted an impact. Impacting was accomplished at 4, 6, and 8.1 mph in one direction and at a speed of 8.1 mph in the opposite direction. The 4 and 6 mph impact speeds were approximate; the 8.1 mph speed was a minimum. Impact speeds were determined by using an electronic counter to measure the time required for the specimen car to traverse an 11-foot distance immediately prior to contact with the anvil cars (see Figure 1, page 3-4).

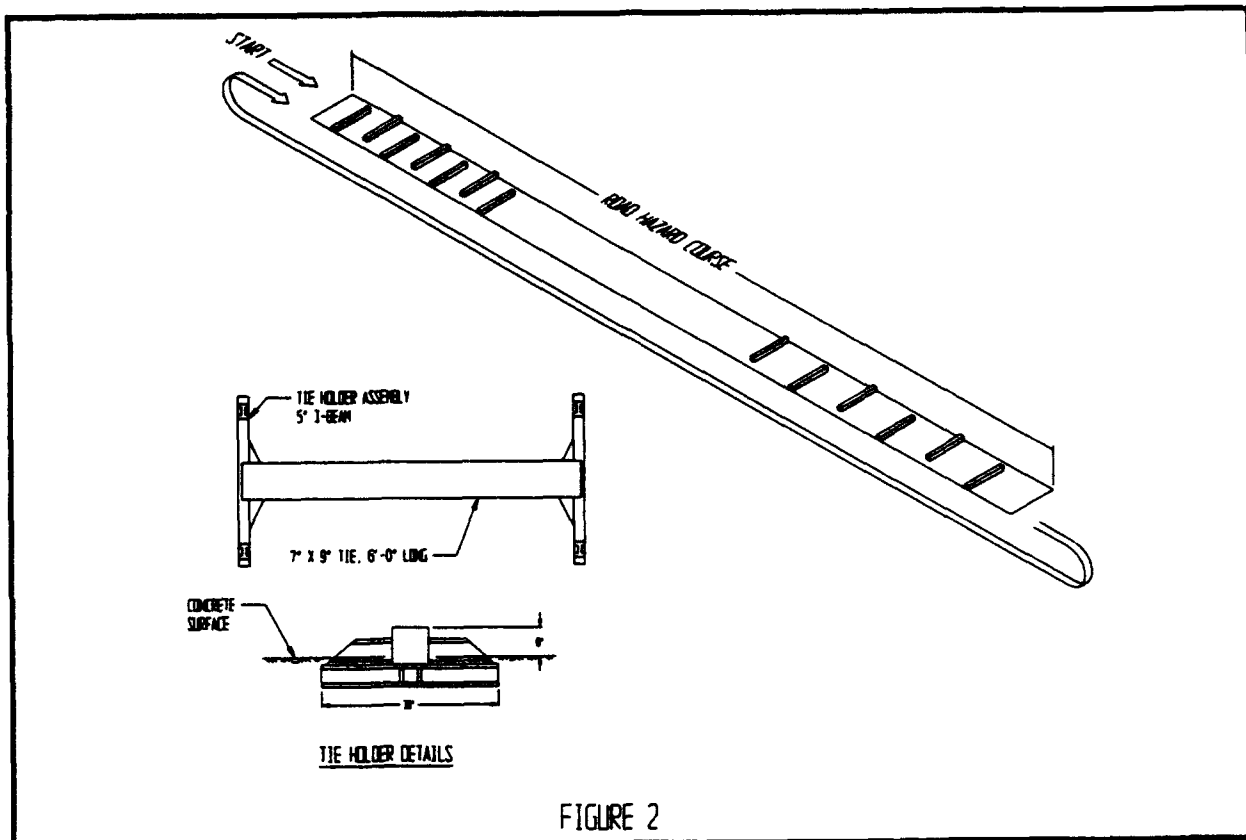
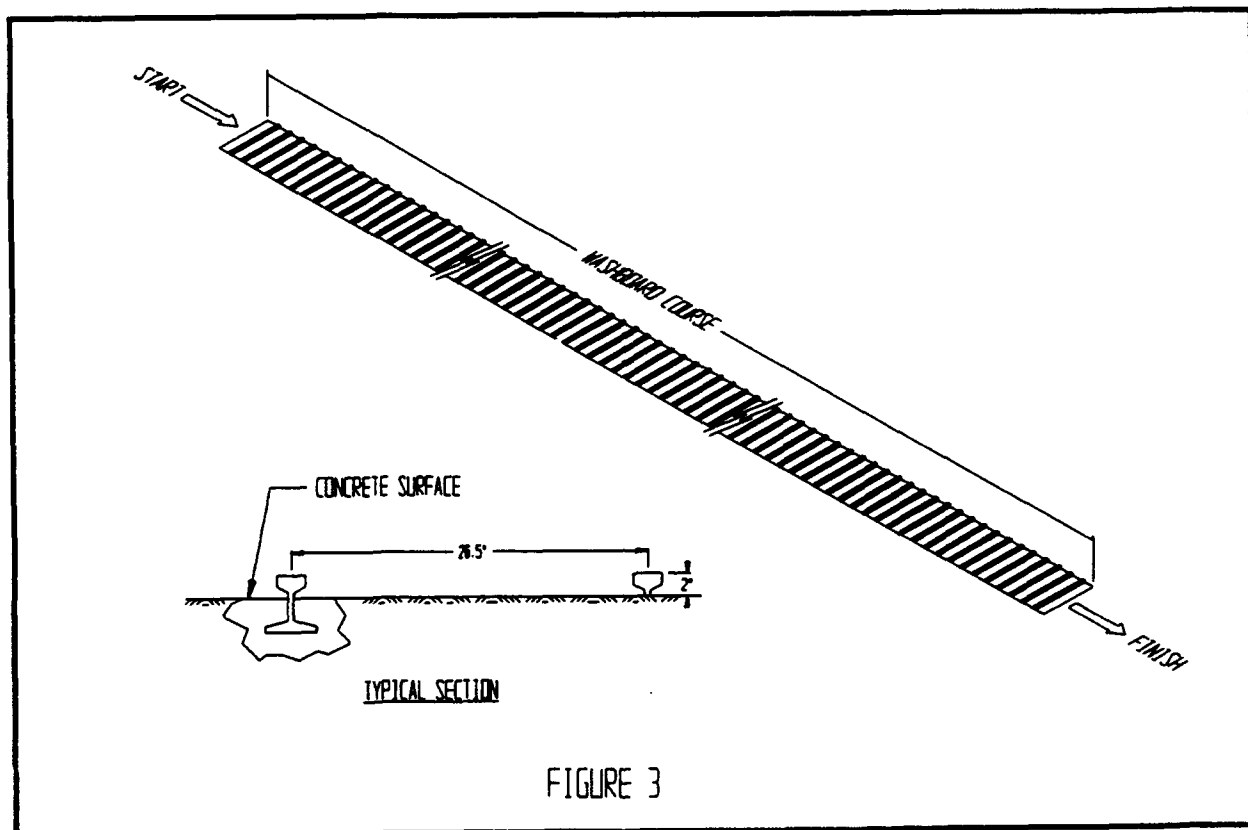
2. Test Method No. 2 (Road Hazard Course). This method required the chassis-mounted container be pulled over the 200-foot-long segment of concrete-paved road which consists of two series of railroad ties projecting 6-inches above the level road surface. The container traversed this course two times. The road hazard course is constructed as shown in Figure 2, page 3-5.

5. Test Method No. 5 - (Washboard Course). The chassis-mounted container was pulled over the washboard course at a speed which produced the most violent response in the container. The washboard course is constructed as shown in Figure 3, page 3-5.

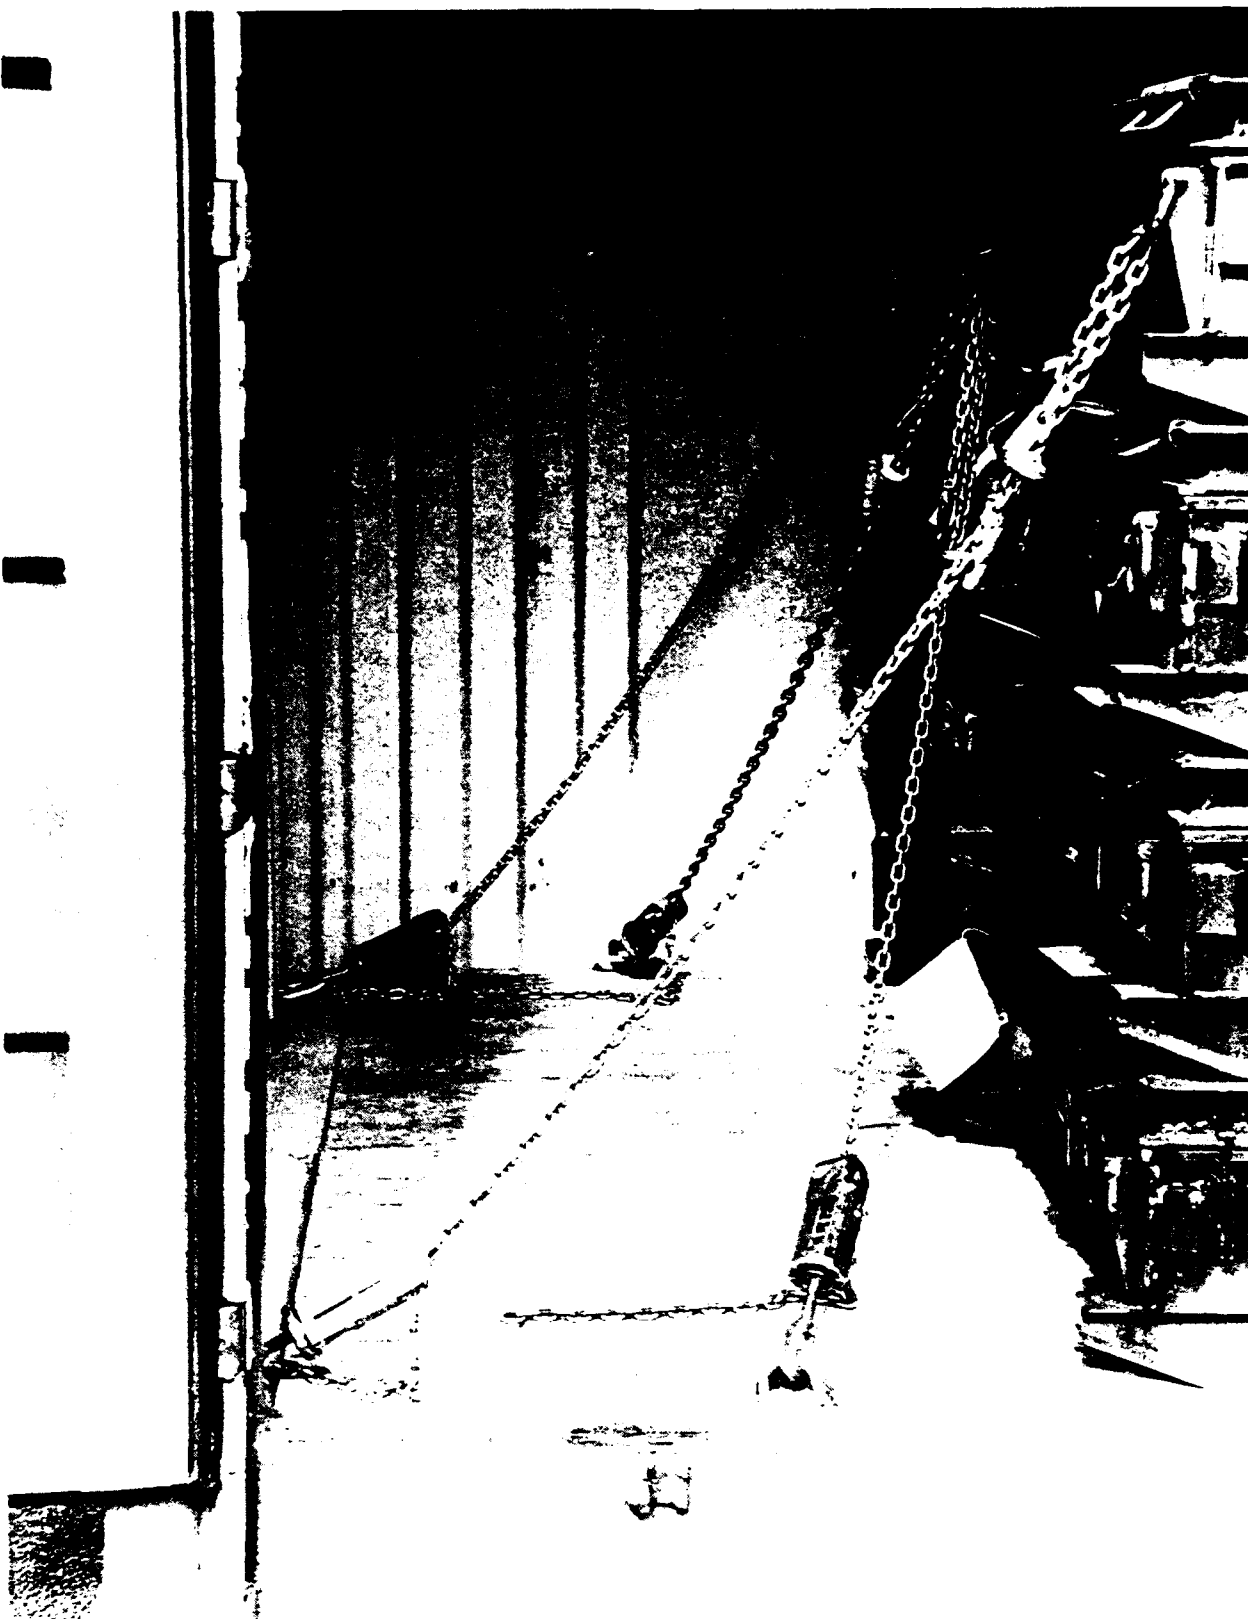
A0317-SPN93-106-1136. This photo shows the aft end of a side-opening container loaded with CNU-310/E containers. The chains and tensioning devices are used to secure the load to the container tiedown provisions.

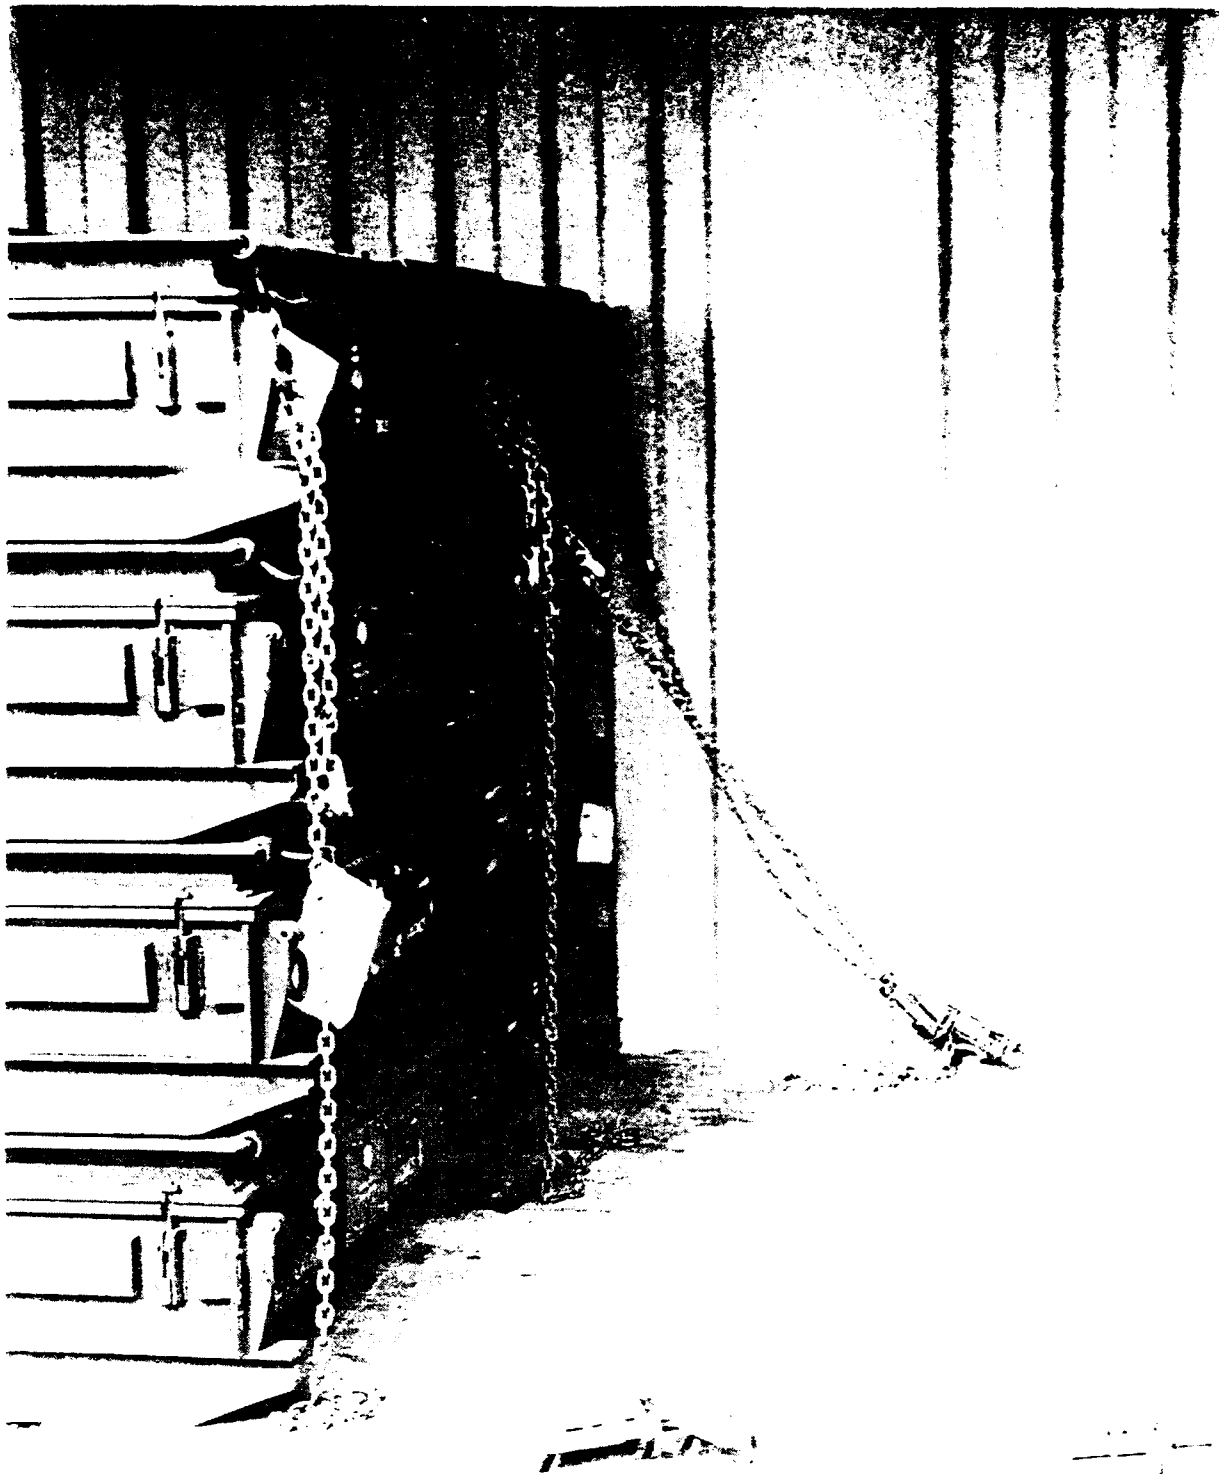
<u>Impact</u>	<u>End Struck</u>	<u>Velocity</u>	<u>Remarks</u>
1	Forward	4.56	
2	Forward	6.39	
3	Forward	8.52	Chains became loose on the opposite impact end.
4	Aft	8.62	Three container tiedown provisions failed. The chains and tensioning devices were not damaged.

A0312-SPN93-106-1137. This photo shows three chain assemblies that failed after a rail impact speed of 8.1 mph in reverse. Two chains pulled from the tensioning device and one pulled the tiedown provision from the floor.

E. RECOMMENDATIONS. The chains and tensioning devices appeared to have sufficient strength to hold eight CNU-310/E containers in a side-opening commercial ISO container; however, the various containers used for these tests do not have tiedown provisions with sufficient strength to safely secure the load. Additional tests should be performed to determine the strength of the tiedown provisions. These strengths should be compared to the procurement requirements and MIL-STD-209H, Military Standard Slings and Tiedown Provisions for Lifting and Tying Down Military Equipment.
